INVESTIGATION OF SOLID CADMIUM EMBRITTLE-
MENT IN A-7 AIRCRAFT FAILED SHAFTS AND
HORN FRACTURE SURFACES

Vought Aeronautics Company

AFML-TR-72-249

This report covers an investigation to determine whether failures in A-7 aircraft horizontal tail actuator horn and shaft assemblies could be attributable to the solid cadmium embrittlement phenomenon.

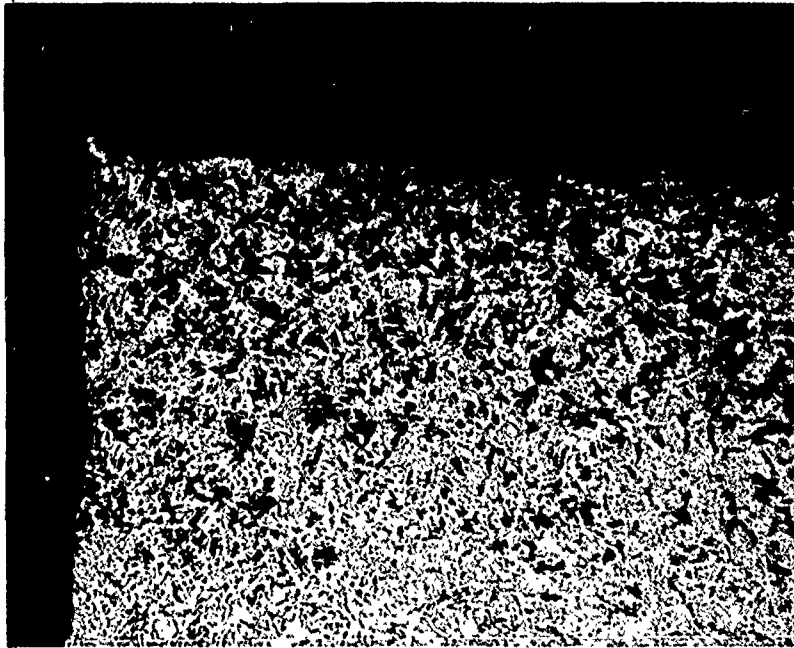
Figure 35. Photomicrograph of Cross-section Through Failure Origin of Shaft from A-7B-137. Tapered Hole at Left and Origin. Top Left a Small Shear Lip Can Be Seen at the Origin. Nitral Etch

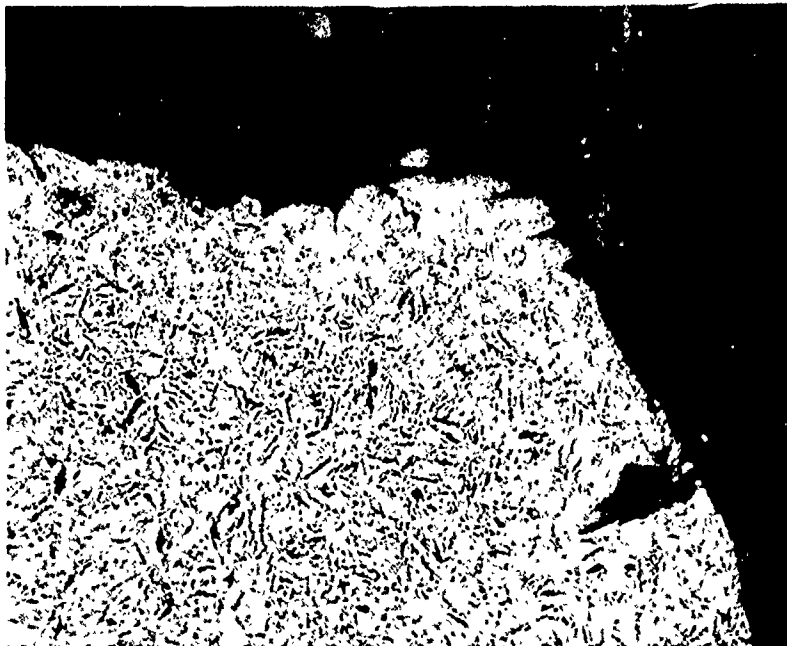
Figure 38. Cross-section of Failure Origin of Shaft from A-7B-121. Some Small Intergranular Cracking Can Be Seen Associated with Fracture. This Origin (Top Right) Had Been Damaged During Failure. Nital Etch

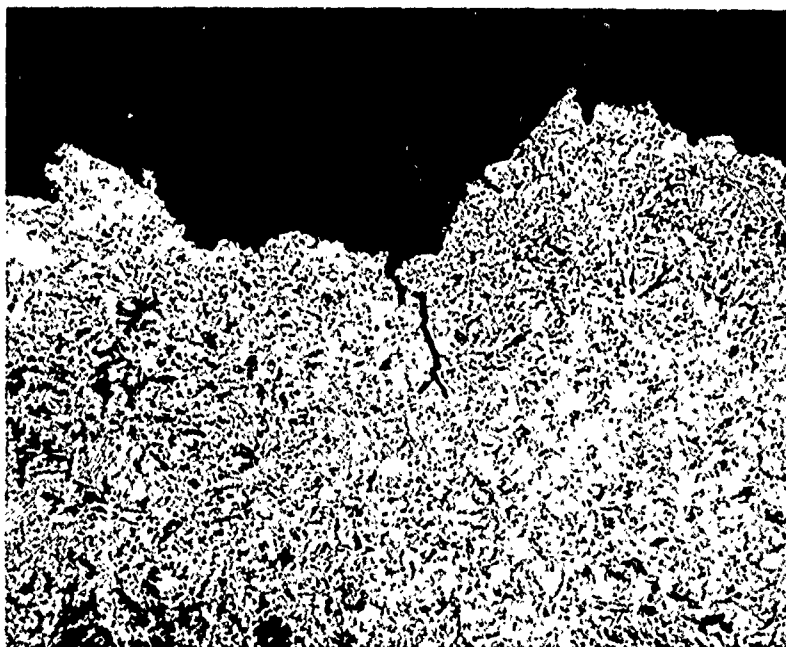
Figure 42. Enlargement of Inboard Intergranular Crack in Figure 41 Above.
Nital Etch

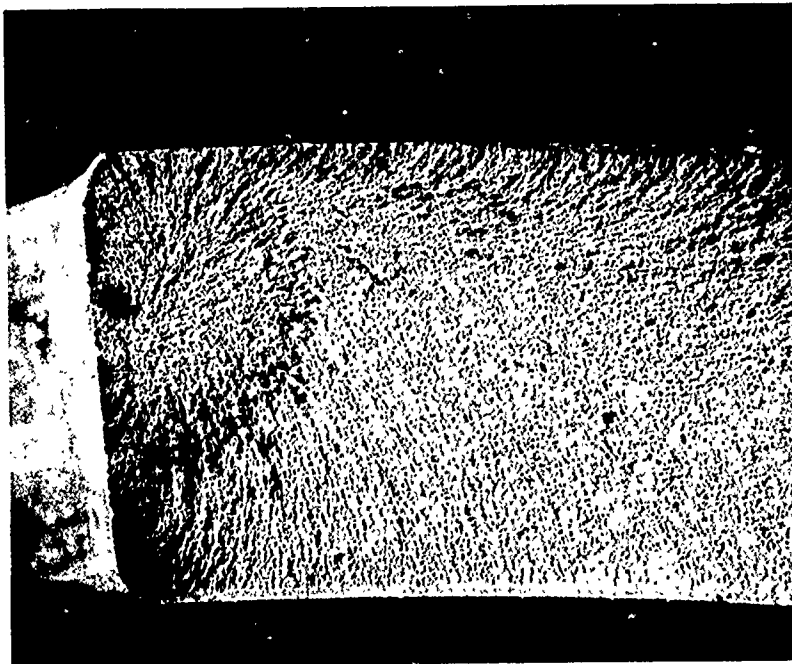
Figure 45. Fracture Origin from a UHT. Shaft Removed from A-7B-137

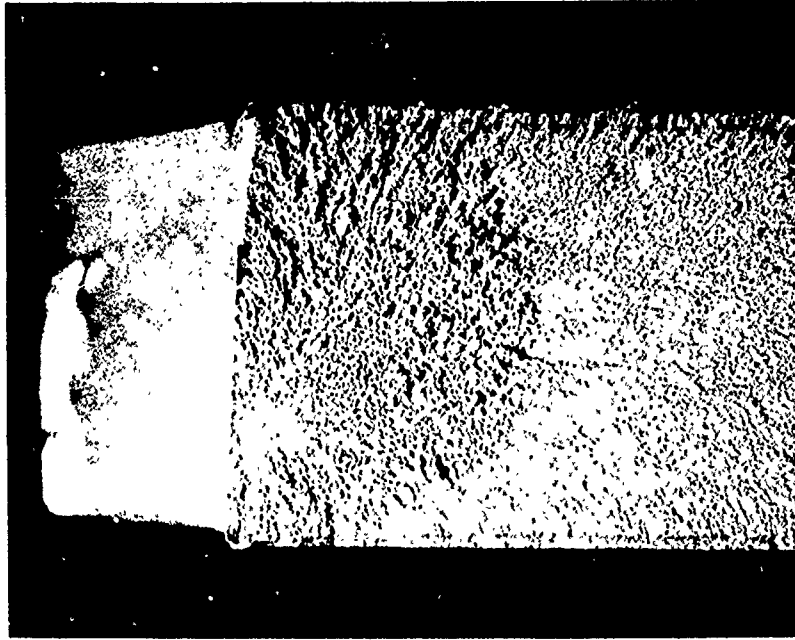
Figure 47. Fracture Origin on UHT Shaft from A-7B-107

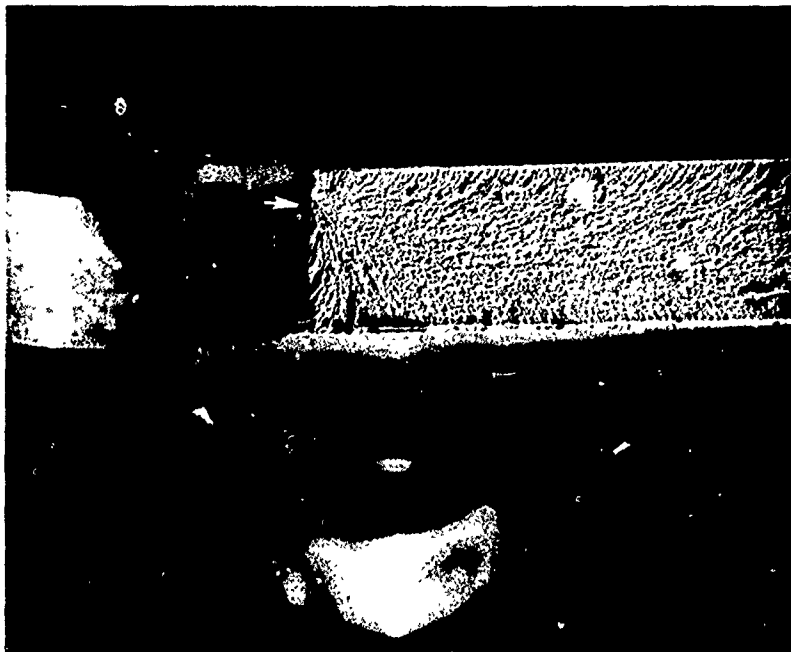
Figure 49. Fracture Origin on UHT Shaft from A-7B-121

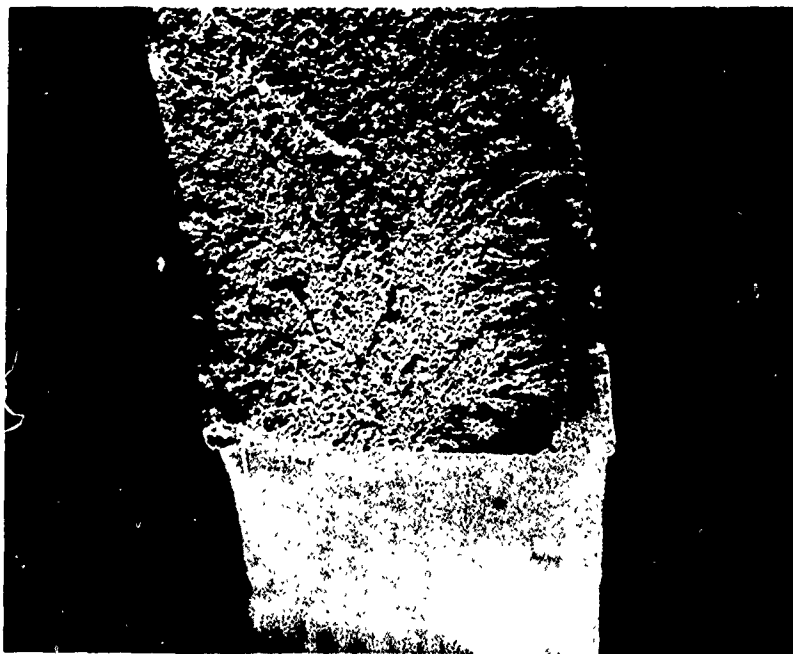
Figure 51. Fracture Origin on a UHT Horn from A-7B-183.

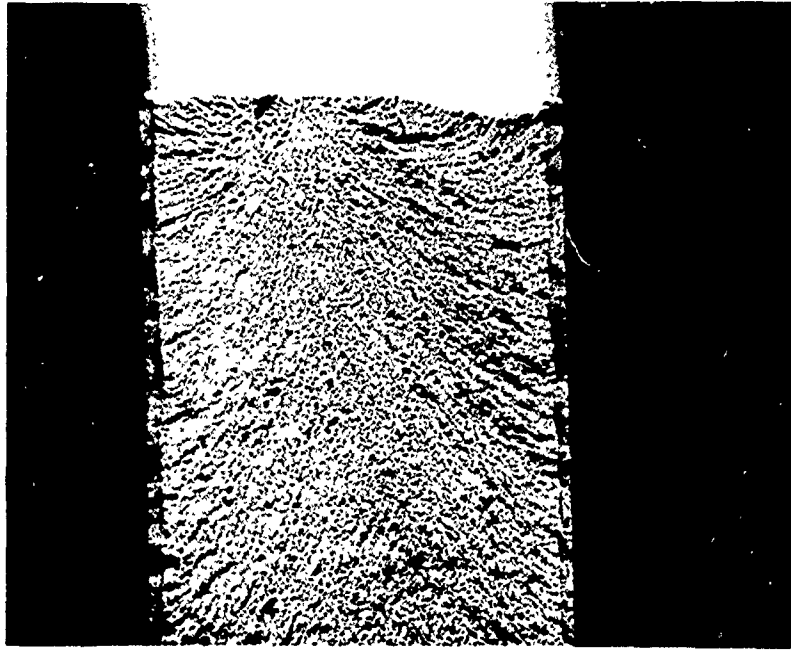
Figure 55. Fracture Origin on UHT Shaft from A-7B-181.

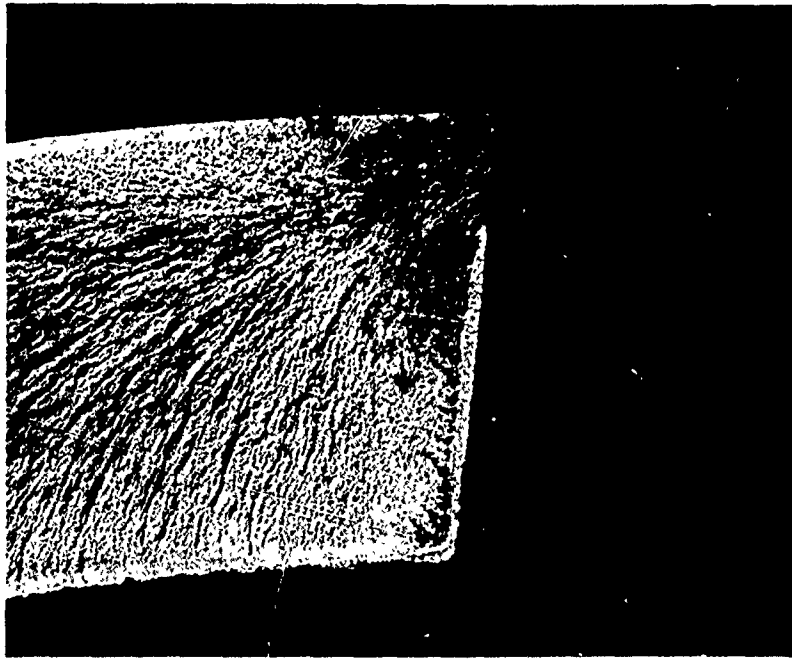
Figure 57. Fracture Origin on UHT Shaft from A-7B-183.
